Re: March 2012 Monthly Progress Report
Administrative Settlement Agreement and Order on Consent for Removal Action
U.S. EPA Region 10 Docket No. CERCLA 10-2009-0255
Gasco Sediments Site within the Portland Harbor Superfund Site

Visual Observations Log Form

Monitoring Period: Monthly (Year 6)—March 2012

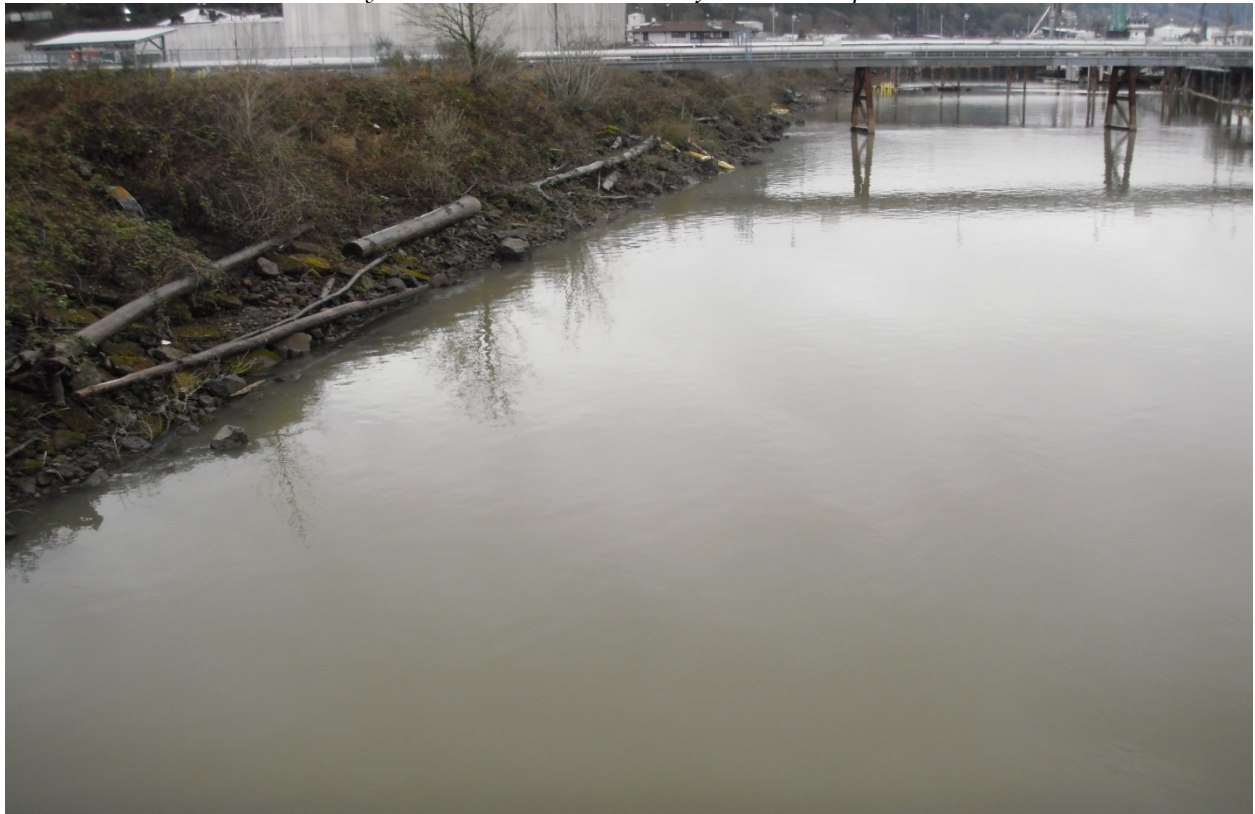
Observations of Erosion/Deposition: No erosion/deposition is evident along the shoreline. The shoreward extent of the cap was not visible due to high river water elevation; and the extents of the organoclay mat material footprint were also submerged. (Photo 1).

Photo 1 — *River level currently elevated above the extent of sediment cap (3/22/12):*

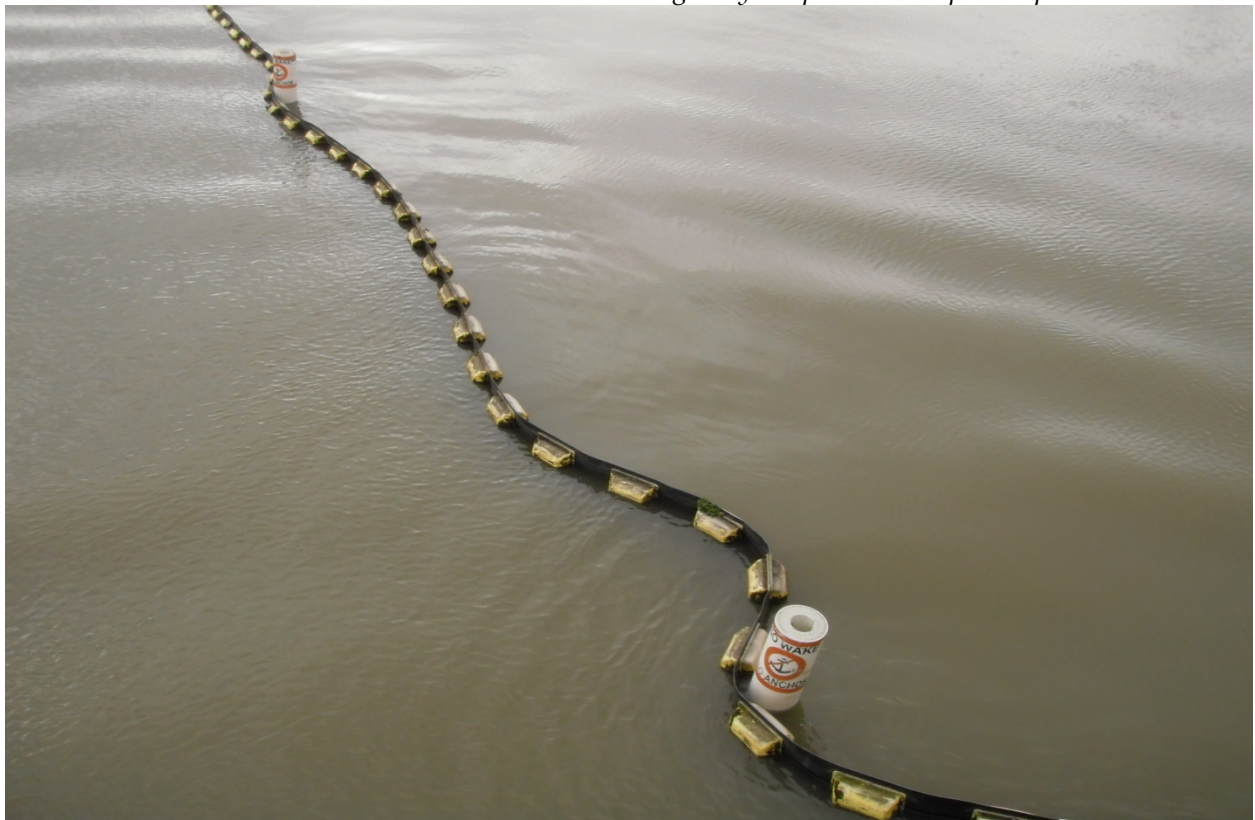
Observations of Long-term Controls (i.e., oil booms, organo-clay mat, etc.) During the observation, the Fuel and Marine Marketing (FAMM) containment boom was placed across the cap area, between the upriver corner of the ship dock and the wooden dolphin (near the upriver extent of the site and near the Siltronic Corporation outfall. Buoys that identify the cap area to mariners are in place as installed. The position of the FAMM oil boom, warning buoys, and a general overview of the site shoreline is shown in Photo 2.

Photo 2 — *FAMM oil boom shown and mariner warning buoys in place across pilot cap area. (3/22/12):*

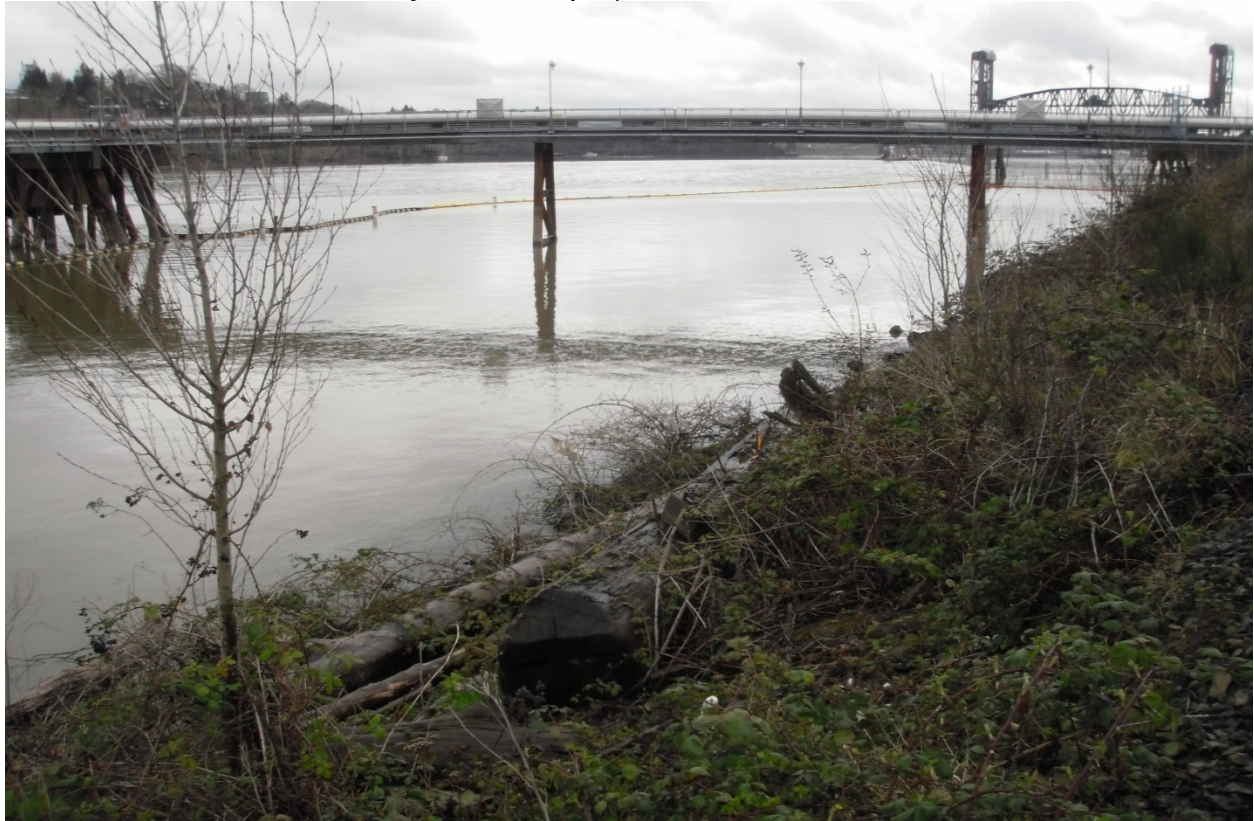
Other Comments: No sheen is evident in or around the cap area. Photo 3 shows the water surface and shoreline immediately downriver of the sediment cap.

Photo 3 — *Conditions immediately downriver of cap area (3/22/12):*
